Tear-down and testing of individual O-Cube blue cells

Greg Daigle
June 26, 2017

This report describes the tear-down and initial testing of the “blue cells” of an Orbo O-Cube.

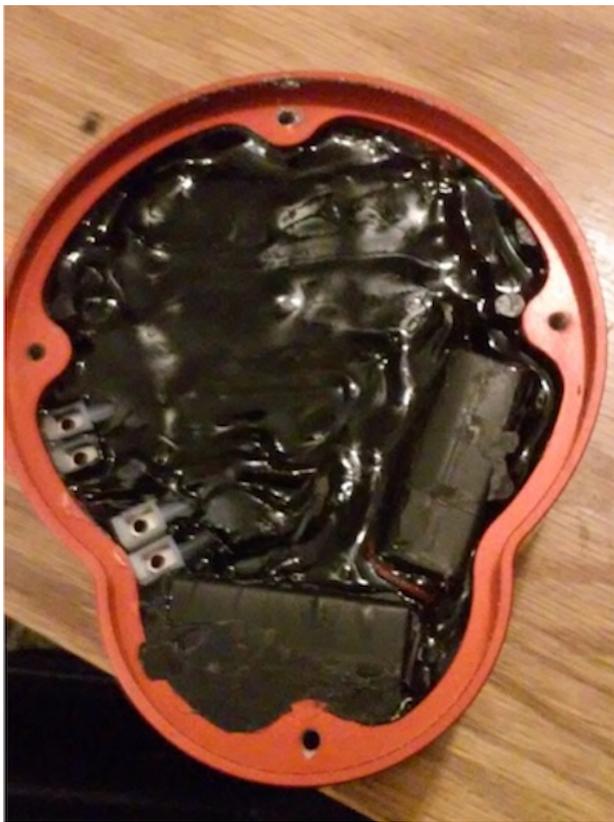
The O-Cube as Frank received it, with back of the housing removed. Filled with mastic.

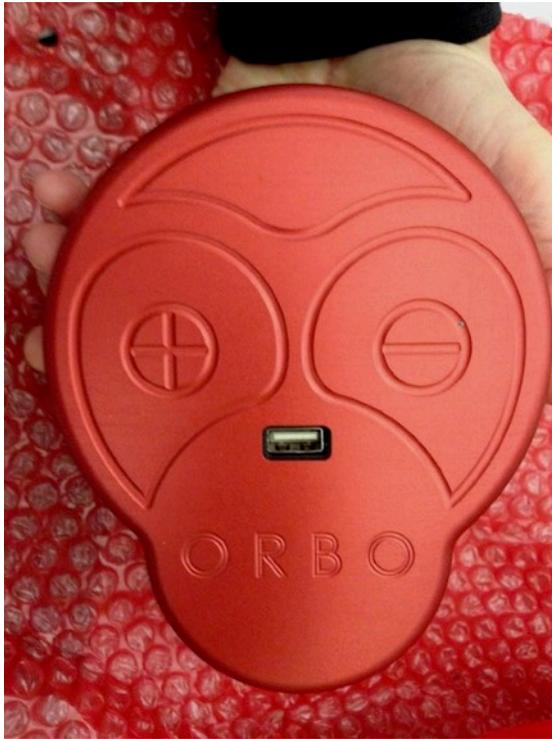
The O-Cube "red skull" housing as sent by Frank.

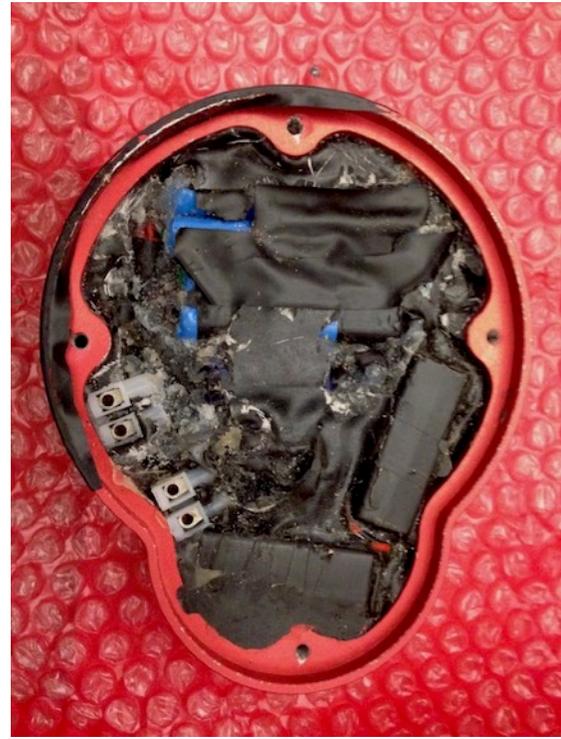
Reverse side of the O-Cube. Note that electrical tape covers almost everything.

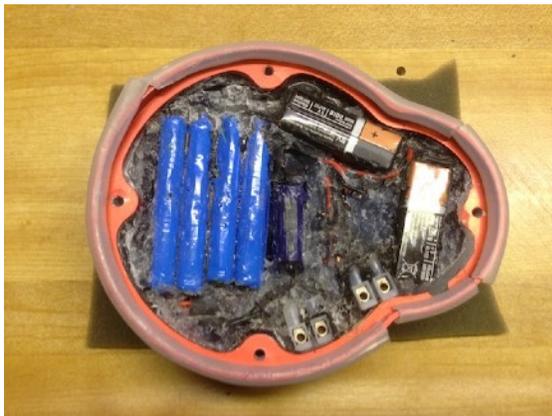
After tape is removed, split polyethylene tubing added to protect the edges of the case from cutting tools. The extent of the matrix material is revealed as well as the positions of the 9v batteries. The matrix is an extremely viscous silicone-like material difficult to remove without cutting or scraping.

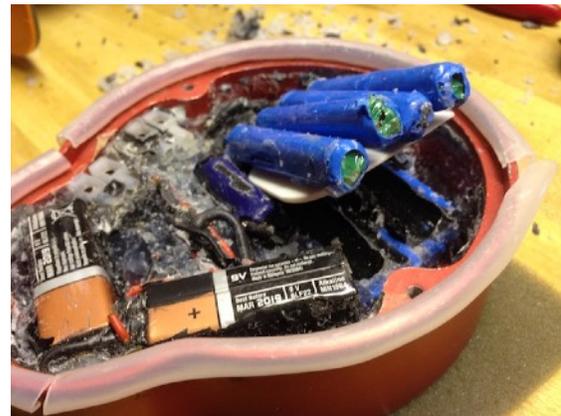
After many hours of scraping and cutting around the blue cells, enough material has been removed to allow the first set of four cells to be pried up.

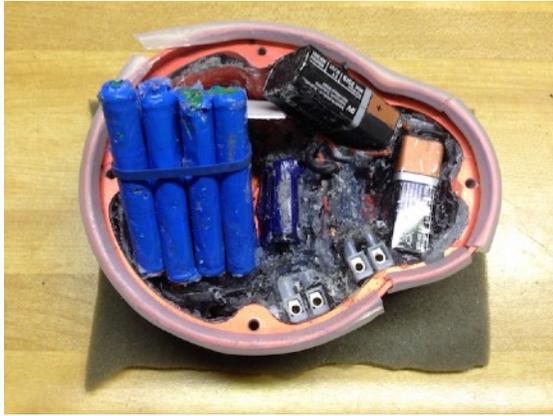
More of the material removed so that now the eight cells can be lifted out, as well as one of the batteries.

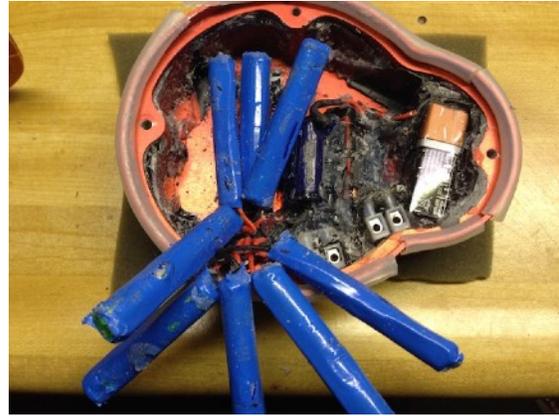
All eight blue cells freed from the matrix and readied for removal.

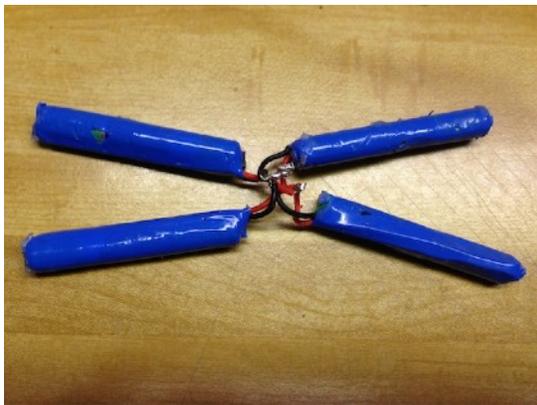
The cells look in good shape though some clearly have had some minor damage inflicted to either the blue plastic covers or to the metal cladding covering the half cells composing each blue cell.

One set of four blue cells separated from the others.

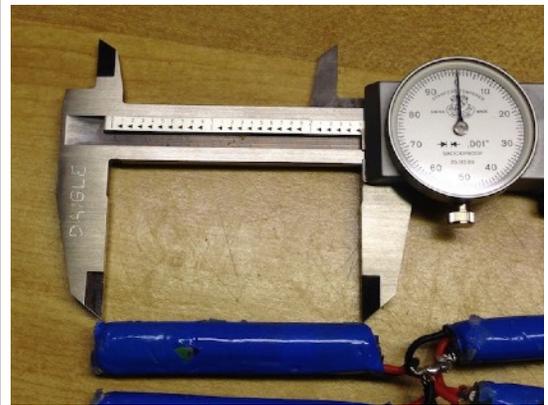
Two of the blue cells with more apparent damage was selected as subjects for testing. Length of the cells is about 2.5".

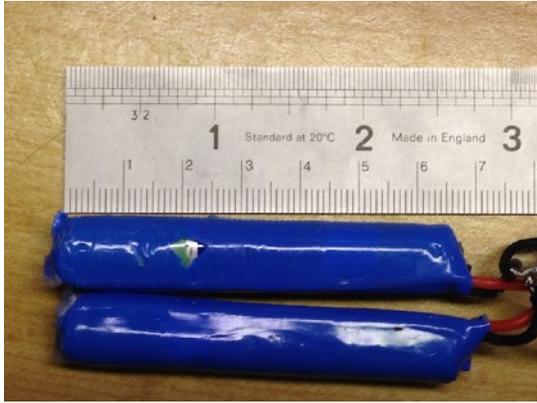
Some damage to one of the blue cell plastic covers is shown.

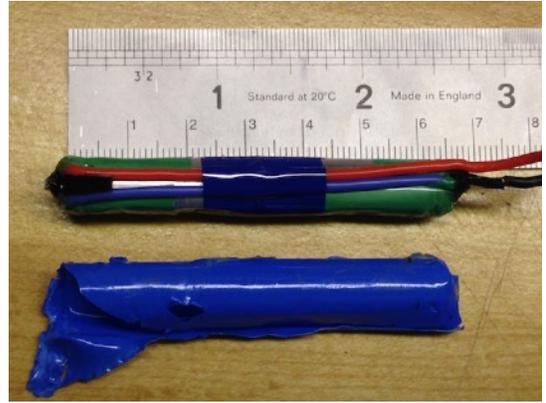
Blue plastic cover is removed. It exposes a cell with layers of insulating clear tape over length of body. Black and red leads from blue cell.

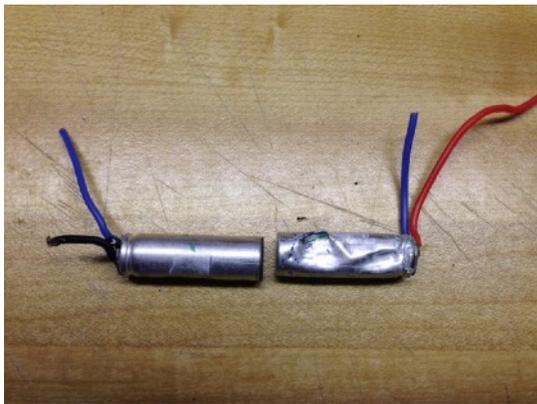
Two half cells in their relative positions within the full cell. One half cell a bit crushed. Blue lead connecting two halves snipped

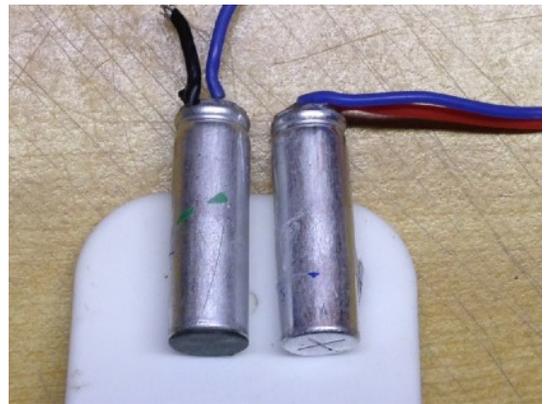
Half cells are identical.

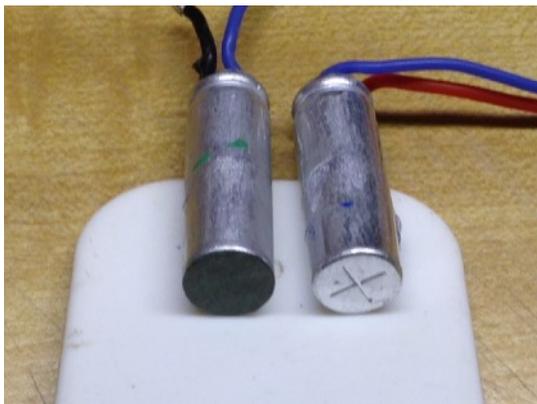
There is a disk between the cells composed of a dense felt-like material, likely conductive.

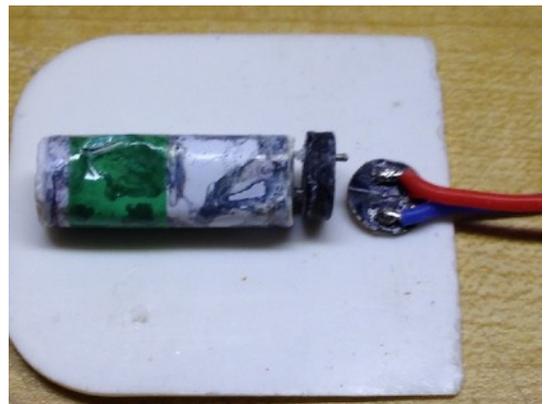
Metal cladding around the most damaged half cell has been removed. Crimped end of the cell has an insulating material. End cap has two leads.

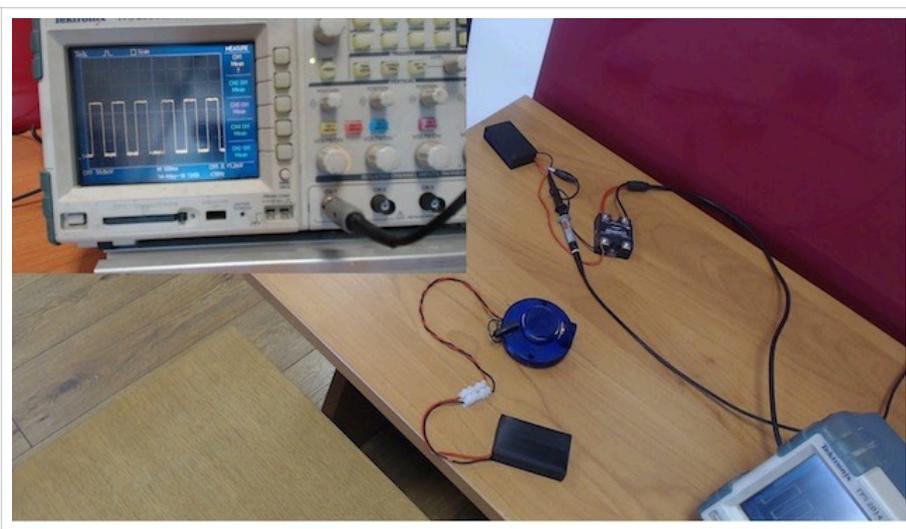
I had tried to use a setup similar to Shaun’s setup (below) where he used a Crydom to charge and discharge the blue cells in order to test their effective lifespan. Separately, Shaun used a set of cells in a black case to run a very simple motor setup with a 3D printed stator (the round blue motor and black box at the bottom of the image).

Screen grab from Steorn, May 2016.

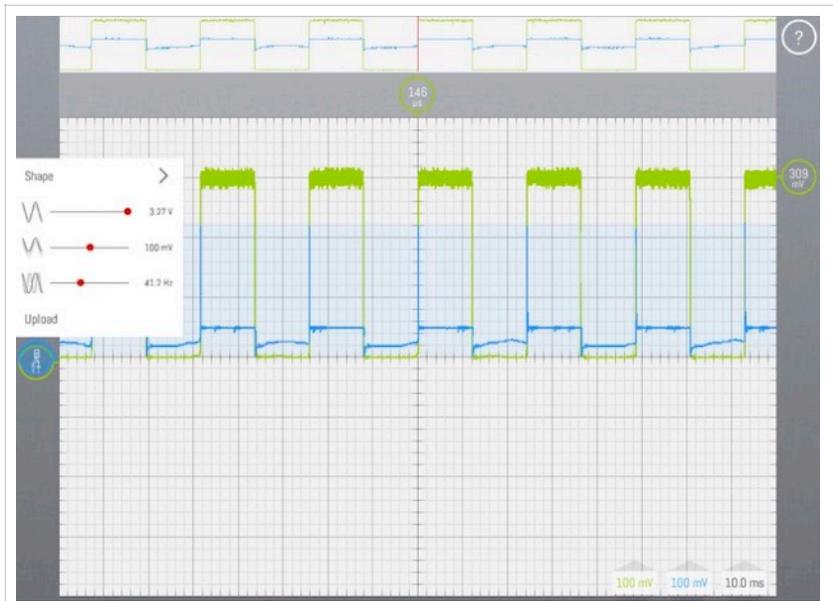
With a Crydom SSR wired to Probe B (green trace) and triggered with the oscilloscope’s trigger output set to maximum of 3.27 V, I was able to run the half cell (Probe A - blue trace) through a series of charge, discharge cycles. The blue trace showed some waveform interference. These readings were with the probes set to x1:

Some waveform interference showing in Probe B.

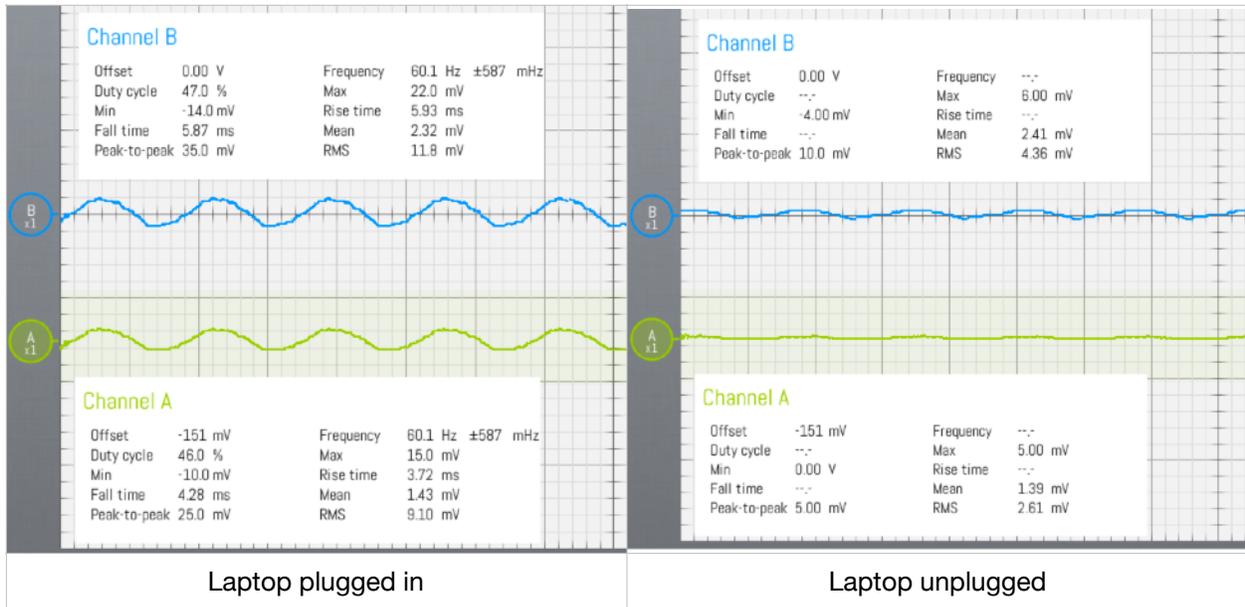
I found that when the laptop was plugged in to its power source, it generated the majority of this waveform. When it was unplugged, it generated a much smaller waveform as indicated by these two below profiles. In another screen capture, the probe leads were removed but the results were the same.

I eventually found two main sources of interference:

- 60 Hz power line noise from the power cord to my laptop.
- 60 Hz power line noise from anywhere inside my stucco home (acts like a large Faraday cage with built-in noise!)

The solution was to use my laptop unplugged and take all readings in the outdoors, preferably more than 100 feet from structures and any overhead power lines. This often occurred in a non-running vehicle.

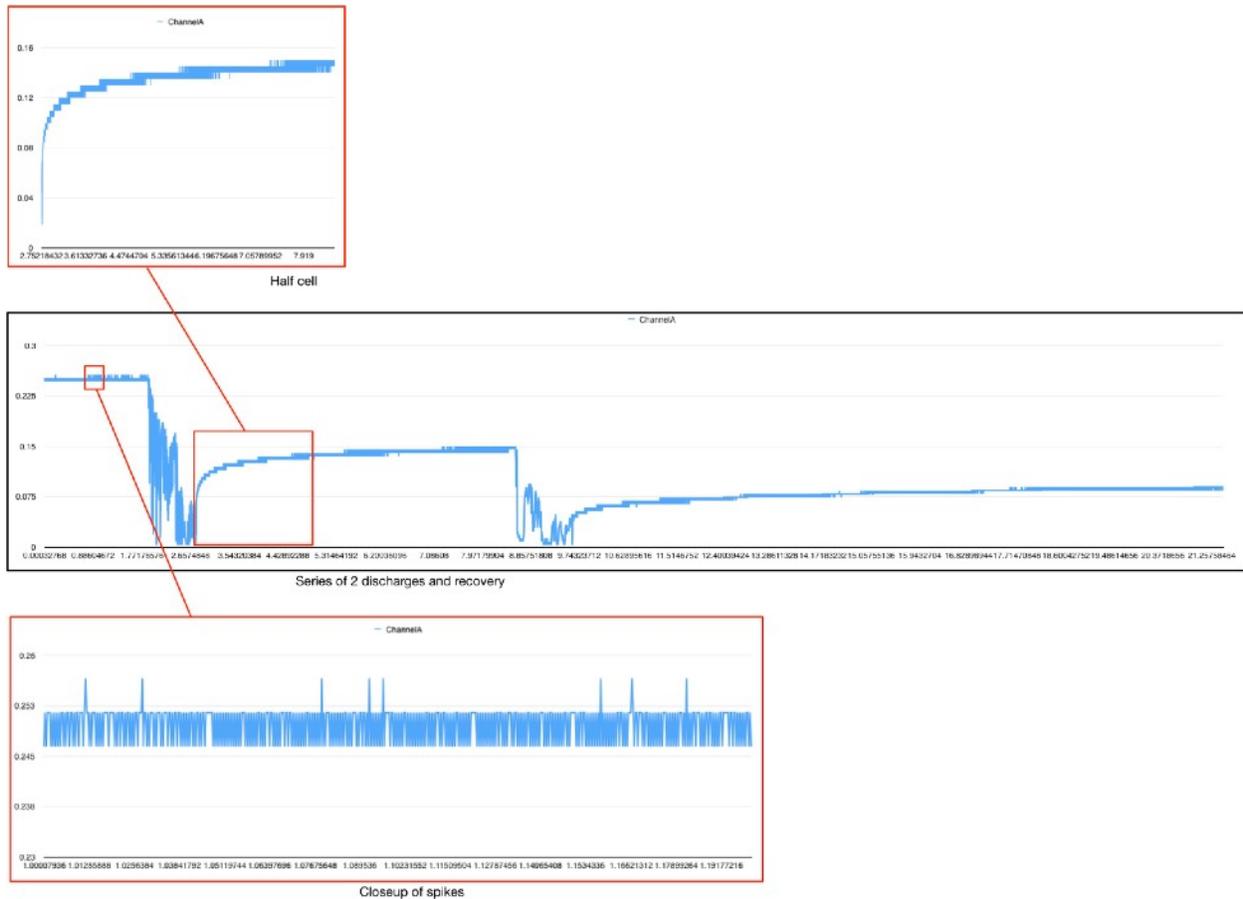
The following composite shows portions of a discharge session taken 11-6-2016 and consisting of two manual (albeit clumsy) discharges in series of HC1. Each discharge was of about 1 sec in duration. I had discharged HC1 previously, so that is why the beginning voltage was so low its full capacity.

After each manual discharge, the voltage profile rebounds quickly and plateaus fast but with a lower recovery profile than the previous discharge. The sampling period was 20mS, or 0.00032768 seconds according to the .csv output from the SmartScope software.

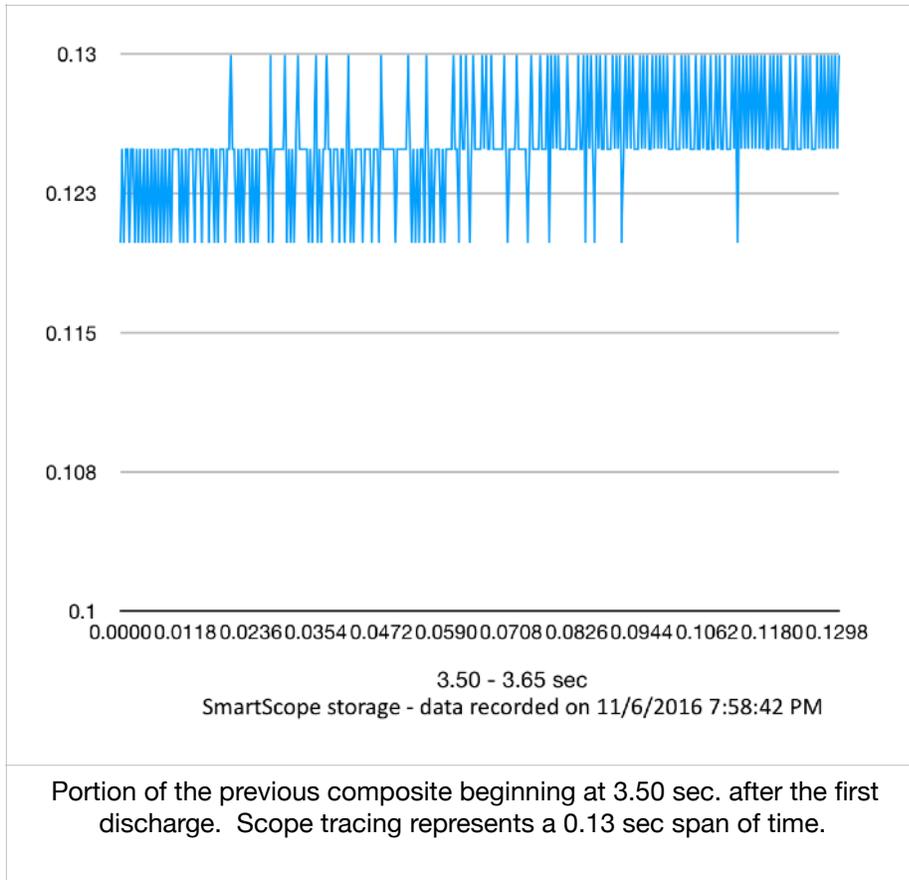
Below is a short segment of the top image in the above composition. You can see the individual spikes and how they aggregate to move the average of the voltage upwards in discrete steps.

With the above measurements of HC1 the voltage steps are 5.06 mV. The same day measurements of FC1 had voltage spikes of 16.79 mV. This is the only time that a significant difference has been seen between spike voltage heights of HC1 and FC1. This will be studied in the future.

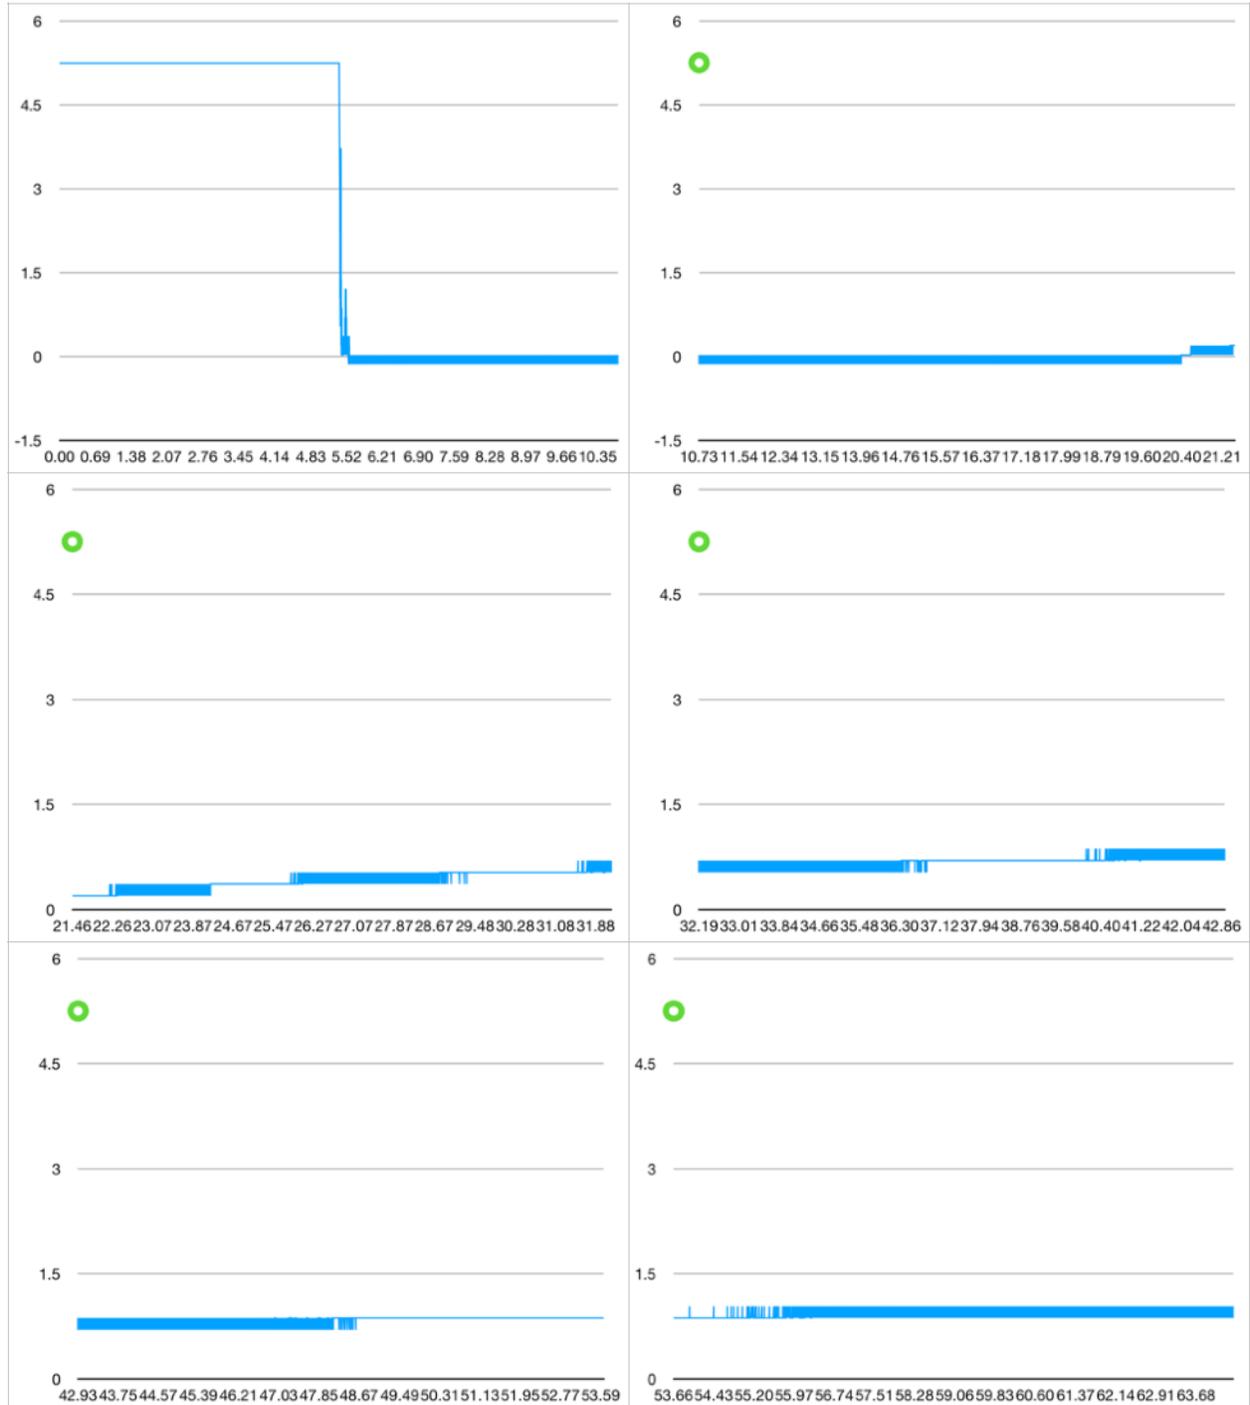
Here is a series of grabs over 64 seconds, starting in the upper left of the table. It was the first discharge of that cell in over a month, with a reading of 480 mV 12 days prior to this test. The beginning voltage for this test was at 524.44 mV. Green circle is starting voltage.

The limitation being that the full .csv export had over 447K data points, and I could only graph 65535 points at a time. After the first 30 seconds of charging I also drew a linear trend line for the rest of the graph. The slope became fairly linear after 30 seconds, if that slope were maintained it would take most of a day for the cell to recharge itself to its original voltage. My experience with the cells is that it would actually take much longer for this to occur.

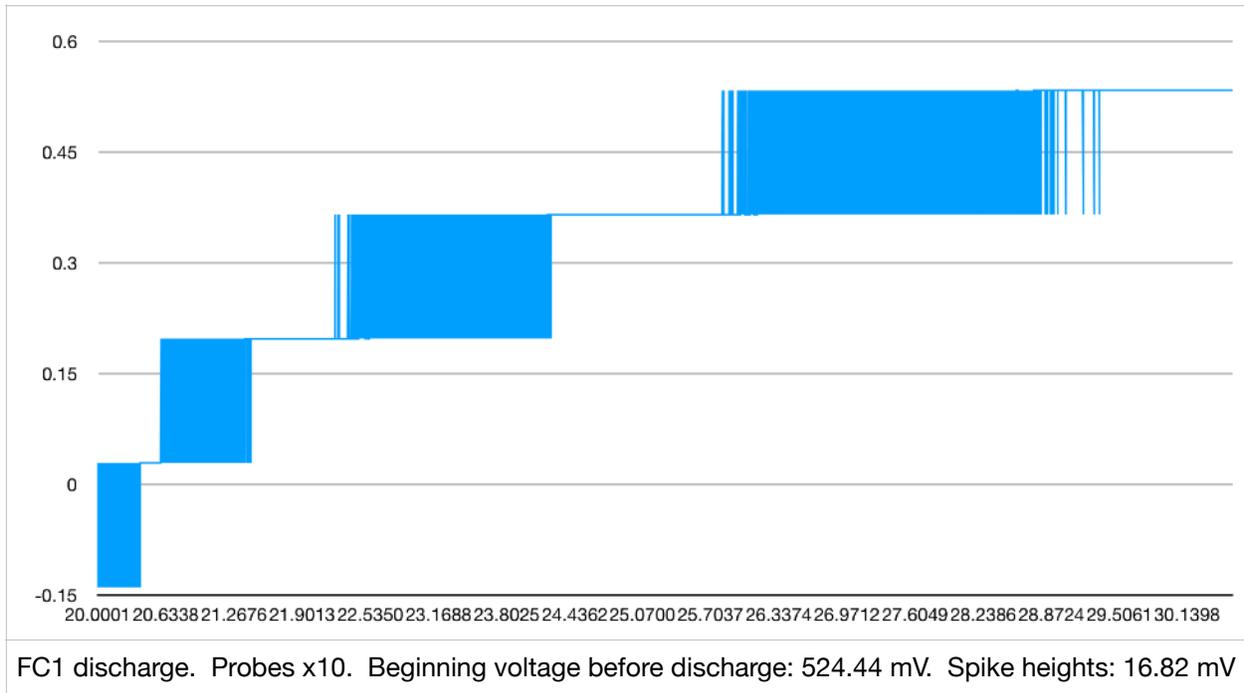
Voltage spike heights are 16.82 mV (again, divide by 10). The below graph is a segment of the total capture soon after the discharge ends.

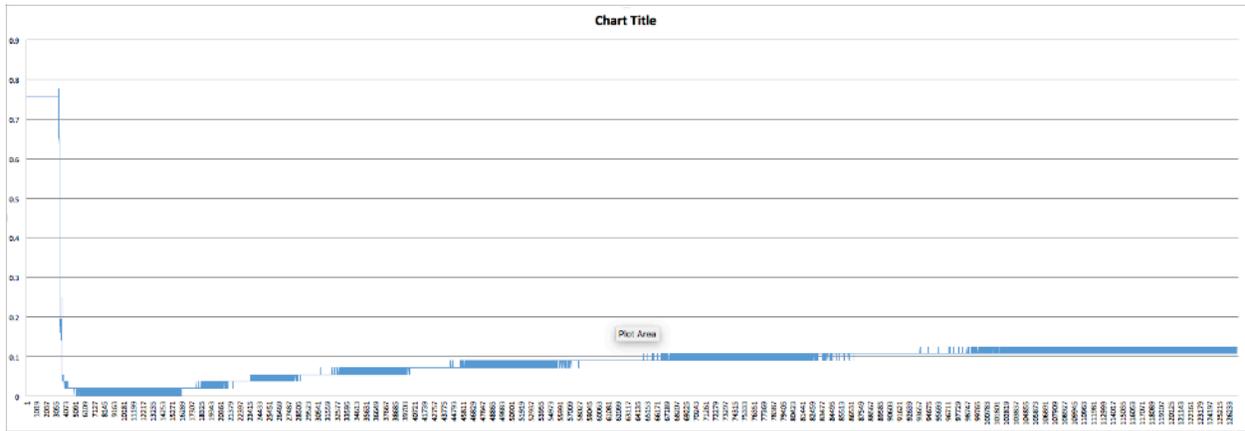
HC1 discharge. Probes x10. Beginning voltage before discharge: 75.79 mV. Spike heights: 17.52 mV

The top image shows a discharge of the HC1. This cell was last discharged the previous day and shows the beginning voltage at 75.8 mV (using x10 probes, so you divide the 758 mV shown by 10). Voltage spike heights are 17.52 mV (again, divide by 10).

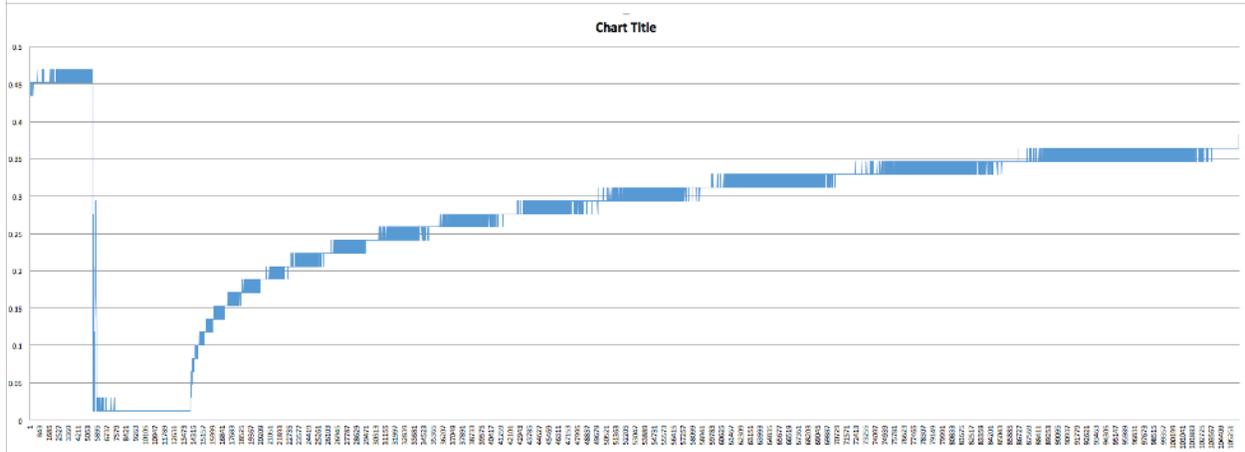
FC1 discharge. Probes x10. Beginning voltage before discharge: 38.18 mV. Spike heights: 17.52 mV

The FC1 full cell discharge is the second image. It had been discharged briefly by accident 12 minutes in advance of this test, which is why the voltage begins at 38.2 mV. Voltage spike heights are 17.52 mV (again, voltage divided by 10).

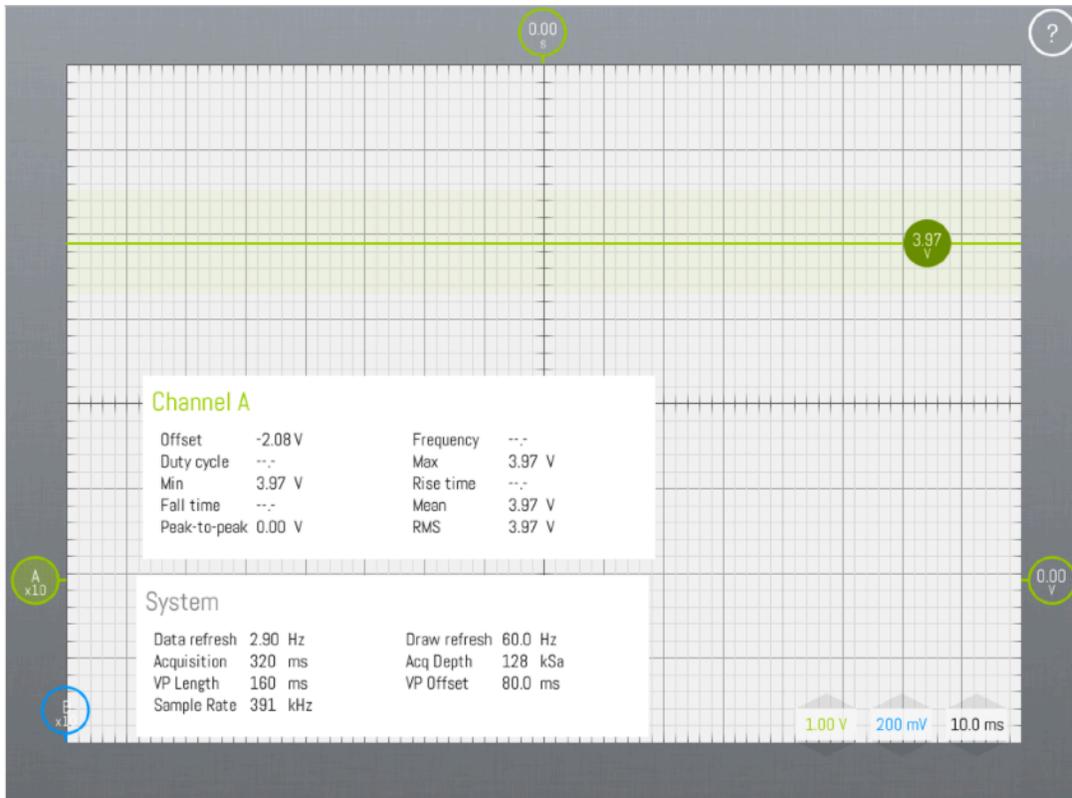
Below is the scope reading of the full cell before the 6 hr discharge. Remember that the probes were x10 so the true voltage is 0.397 volts, not 3.97 volts.

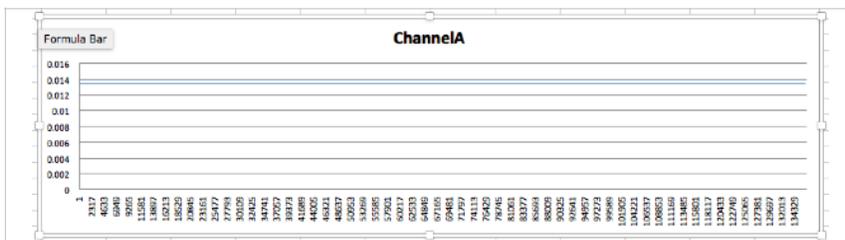
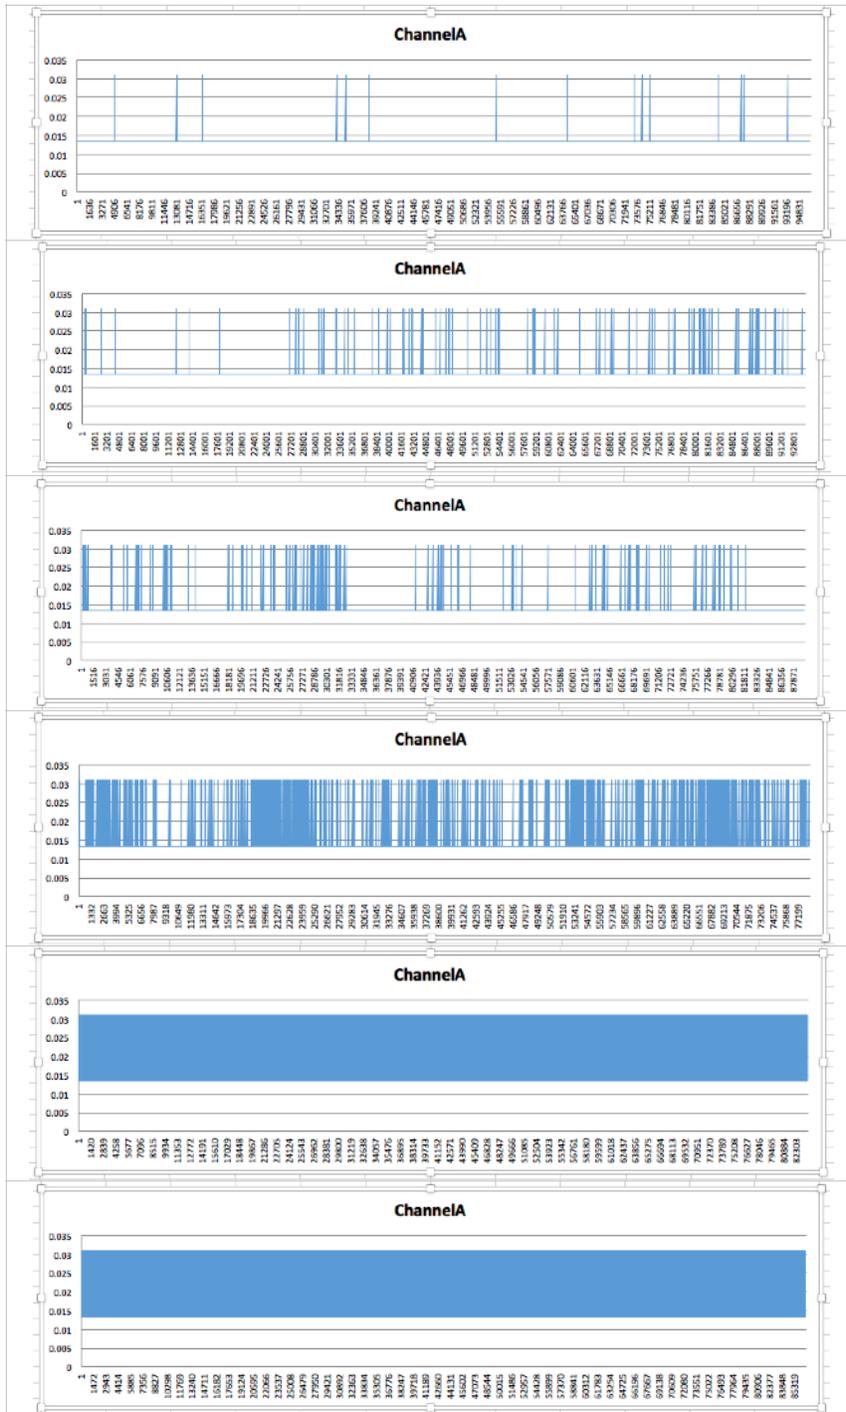
The results of the six hour long discharge of the full cell are below. I found that even though the recovery afterwards is much slower than that of a short discharge, the cells do begin to recharge themselves with spikes of 0.001758962 volts (remember to divide the trace values by 10 since the probes are x10).

I also had to take a series of captures, otherwise the .csv file size would be too large to handle. Each capture was between 12.65 sec and 22.01 sec., with about one minute between captures.

Below is the series of captures over a period of 6 minutes.

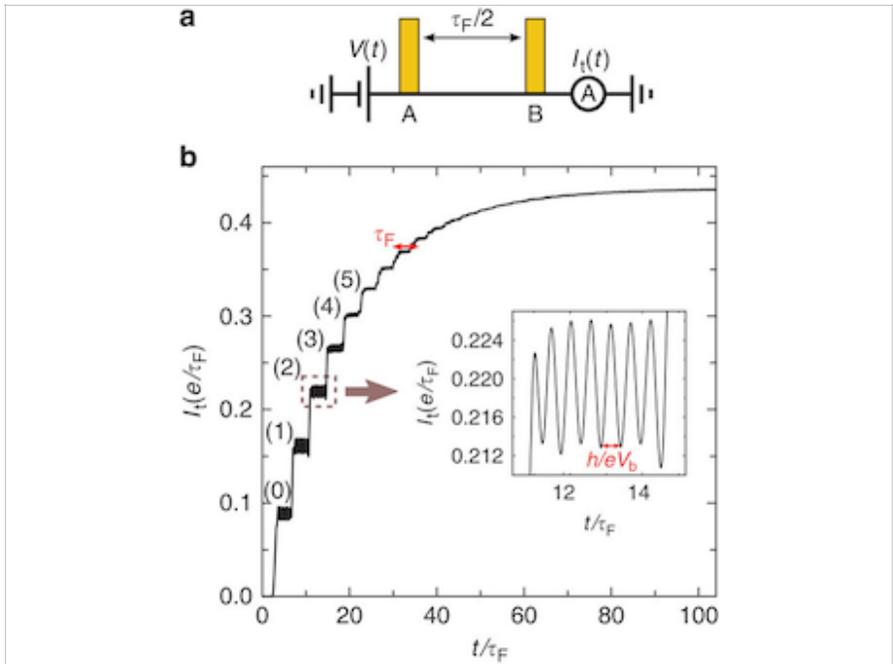
The stepping that I have seen reported in papers on the QHE (see illustration below) show not only the regular steps (possibly Landau levels) but also some of the spiking before each jump. The illustrated plot below is current over time, not voltage over current or voltage over time, but the spikes and steps are clear. Below that illustration is a trace I took of the output from a full blue cell after discharge, shown as voltage over time. Both spikes and steps are clear and regular, but why so many spikes?

The a.c. Josephson effect without superconductivity. [Benoit Gaury](#), [Joseph Weston](#) & [Xavier Waintal](#)

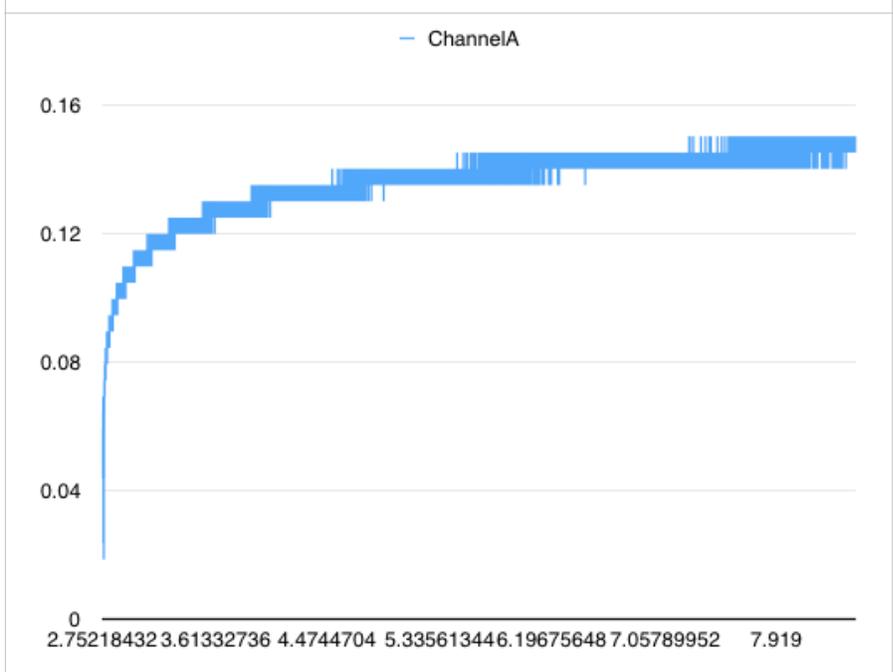
Early discharge profile of HC1.
